QRC EVALUATION OF MATERIALS AND PROCESSES

University of Dayton Research Institute
University of Dayton
Dayton, Ohio 45469

OCTOBER 1982

Final Report for Period 1 April 1980 - 14 June 1982

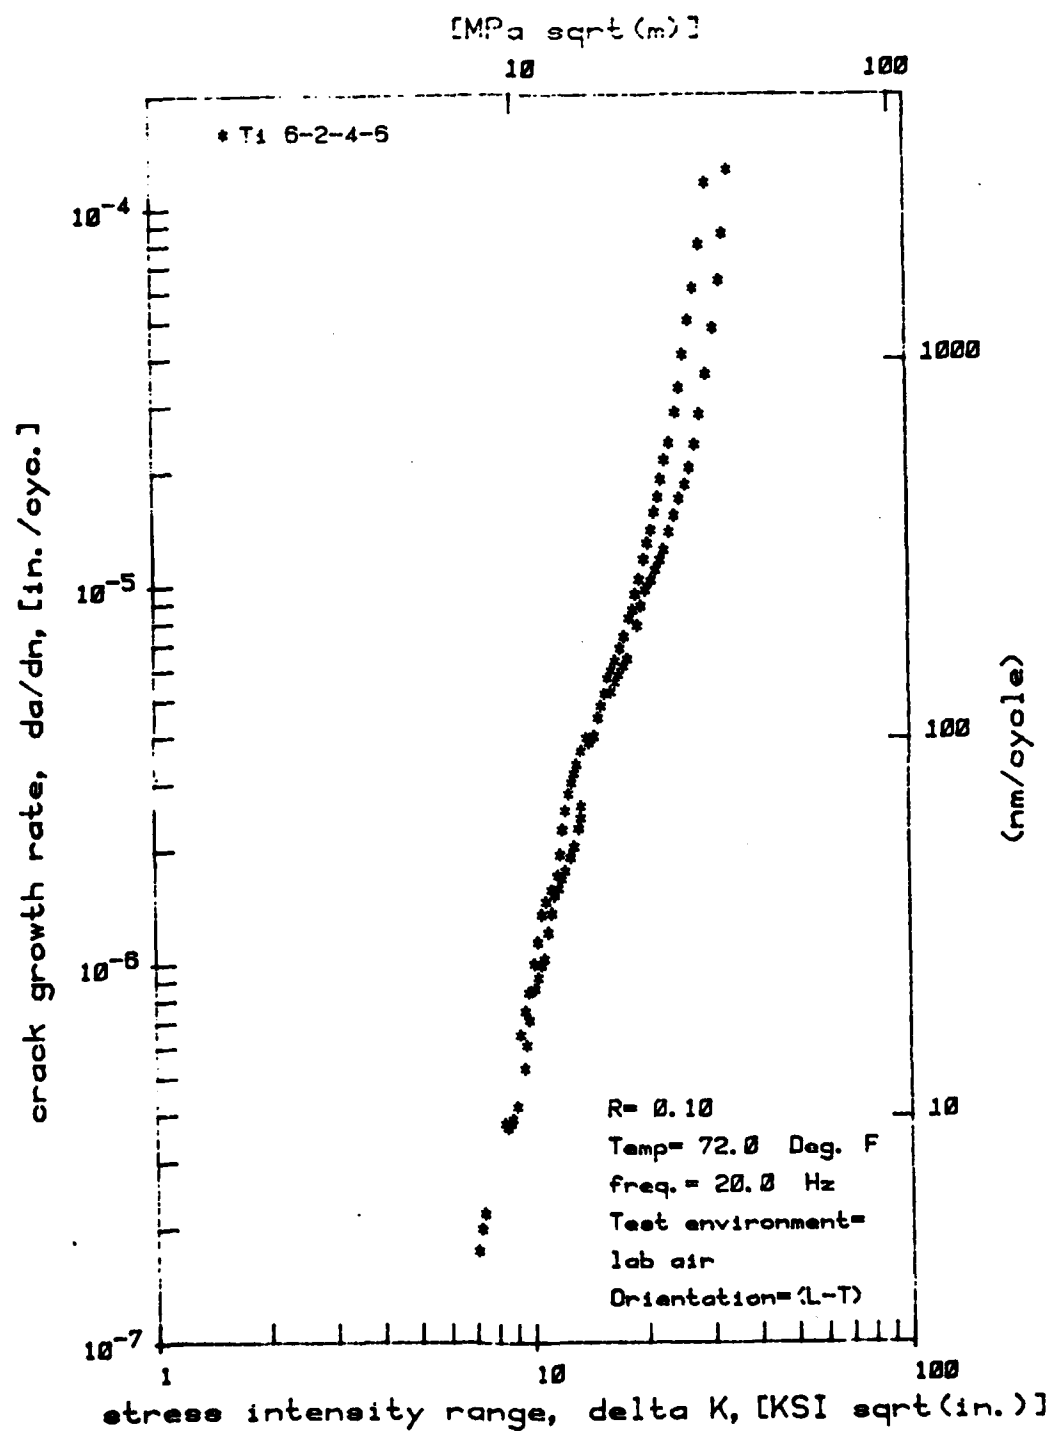
Figure 3. Room Temperature Fatigue Crack Growth Test Results.

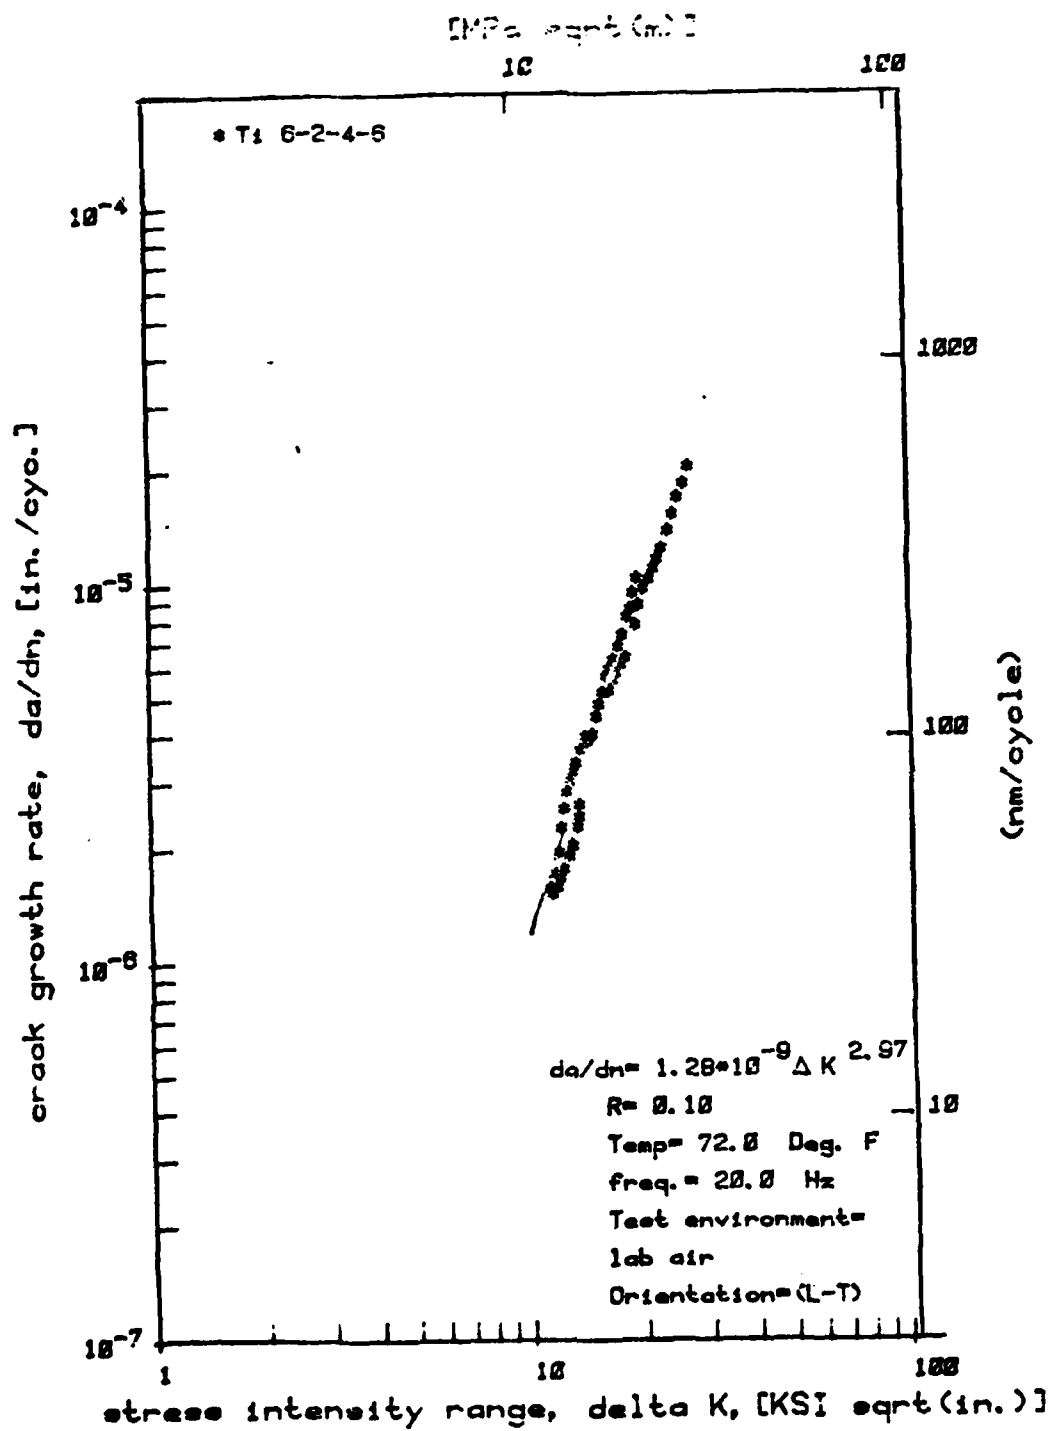
Figure 4. Linear Region of Room Temperature Fatigue Crack Growth Rate Test Data.

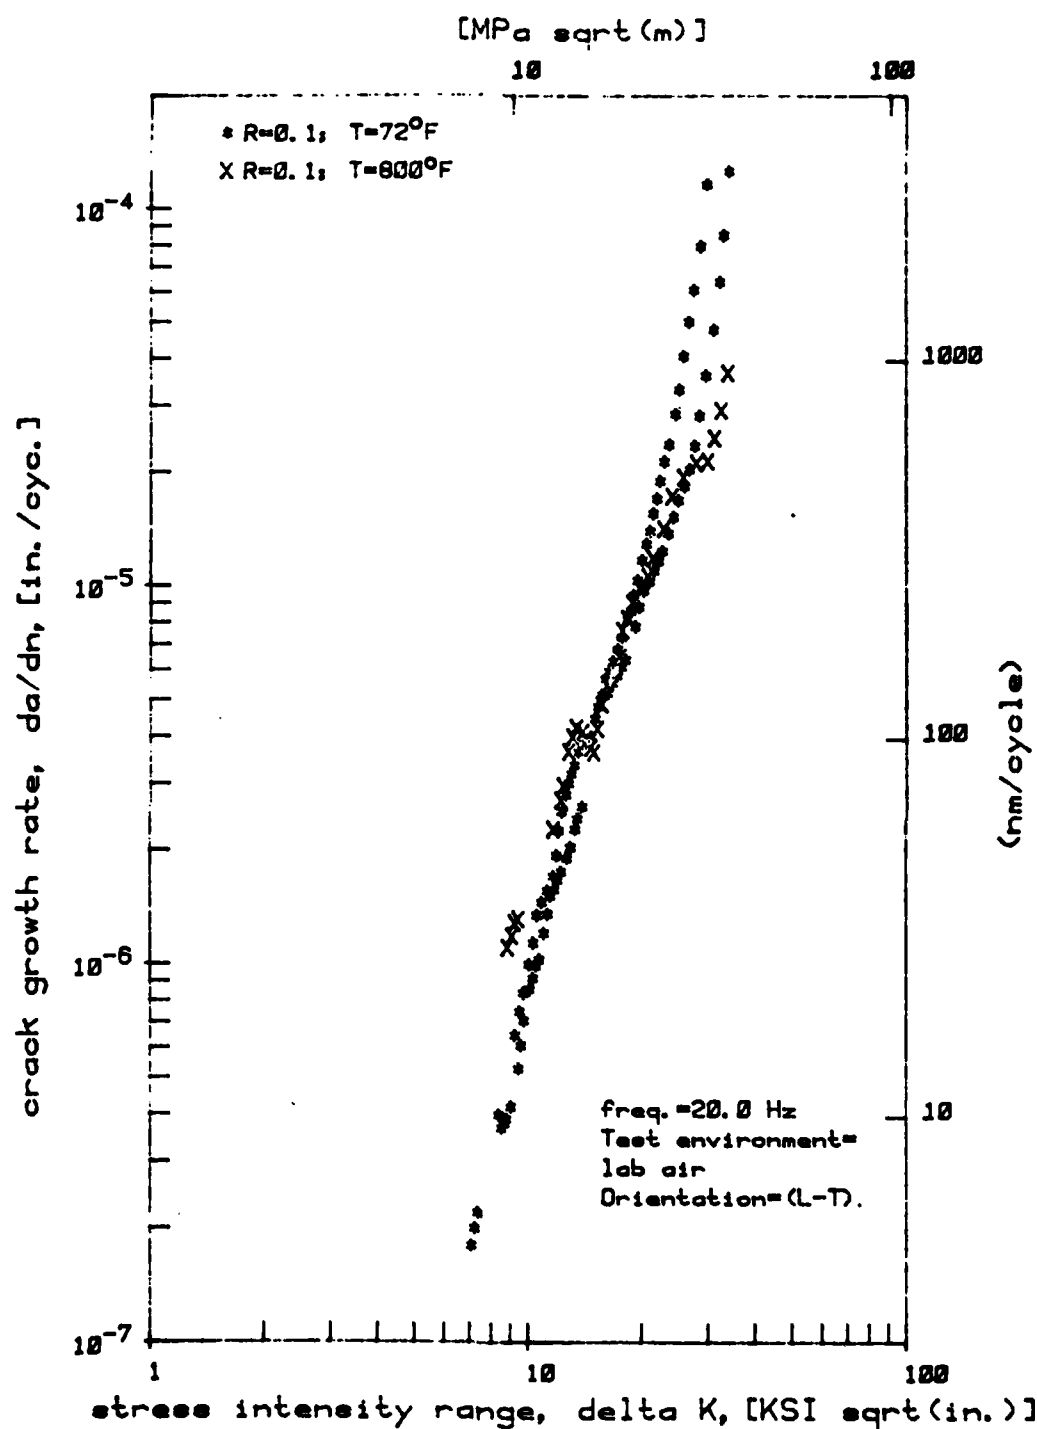
Figure 9. R-ratio Equal to 0.1, Room Temperature and 800°F (427°C) Fatigue Crack Growth Test Data.

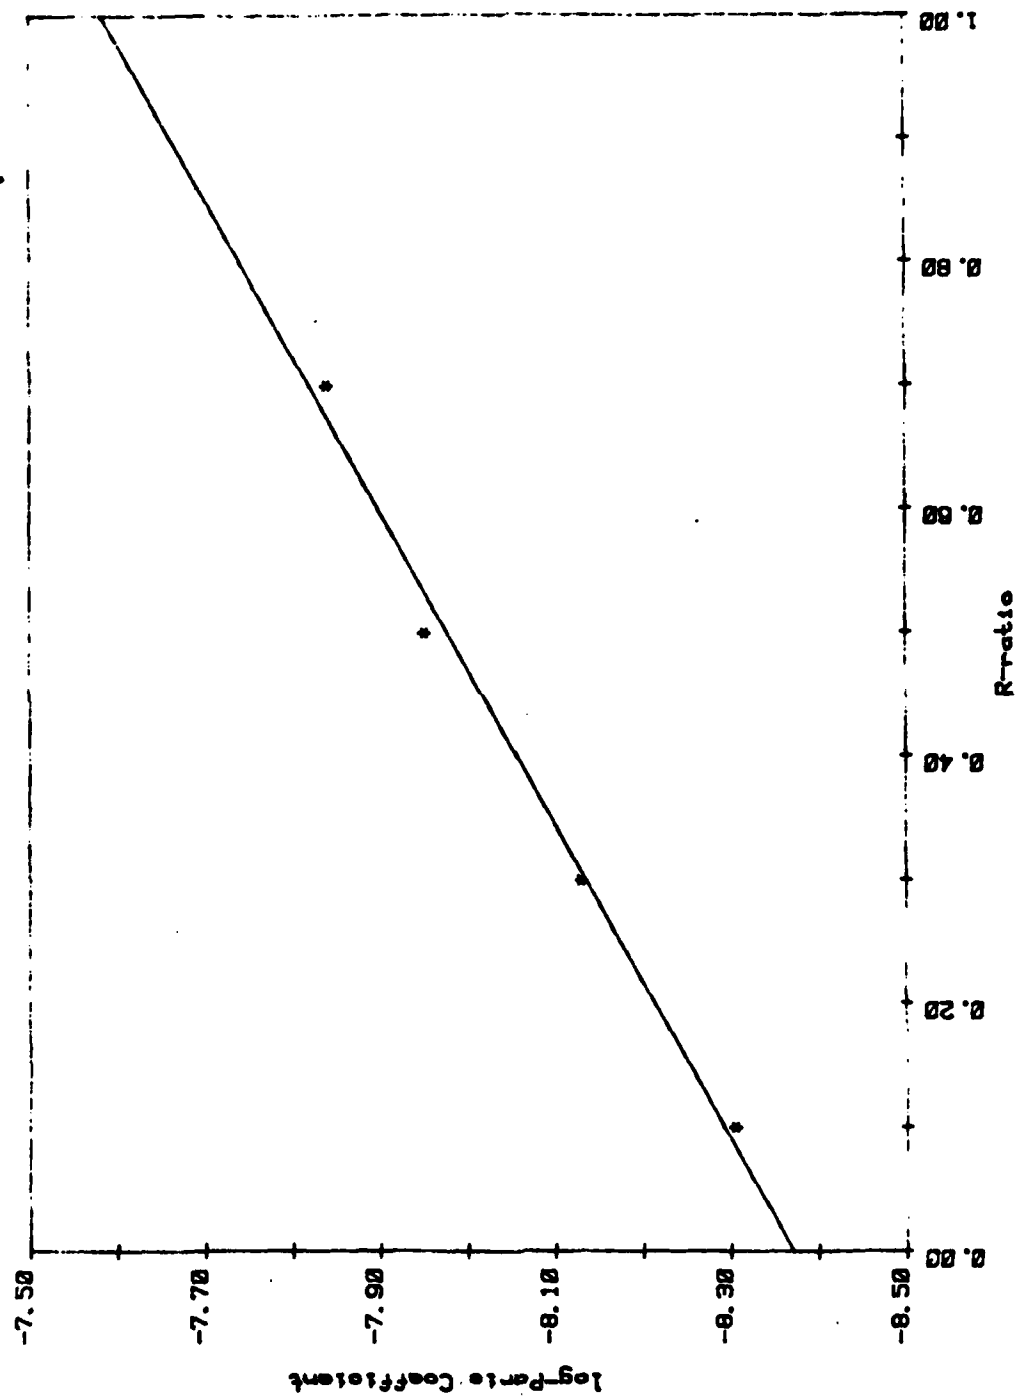
Figure 10. R-ratio Versus Log-Paris Coefficient for 800°F (427°C) Ti6-2-4-6 Fatigue Crack Growth Test Data.

are linearly related for data sets generated at constant loading frequency and test temperature. Figure 10 presents the loading ratio versus the log-Paris coefficients taken from Figures 5 through 8 for the four 800°F (427°C) data sets. Here too, the log-Paris coefficient can fairly be represented as linearly related to the loading ratio for constant loading frequency and an elevated temperature test parameter.

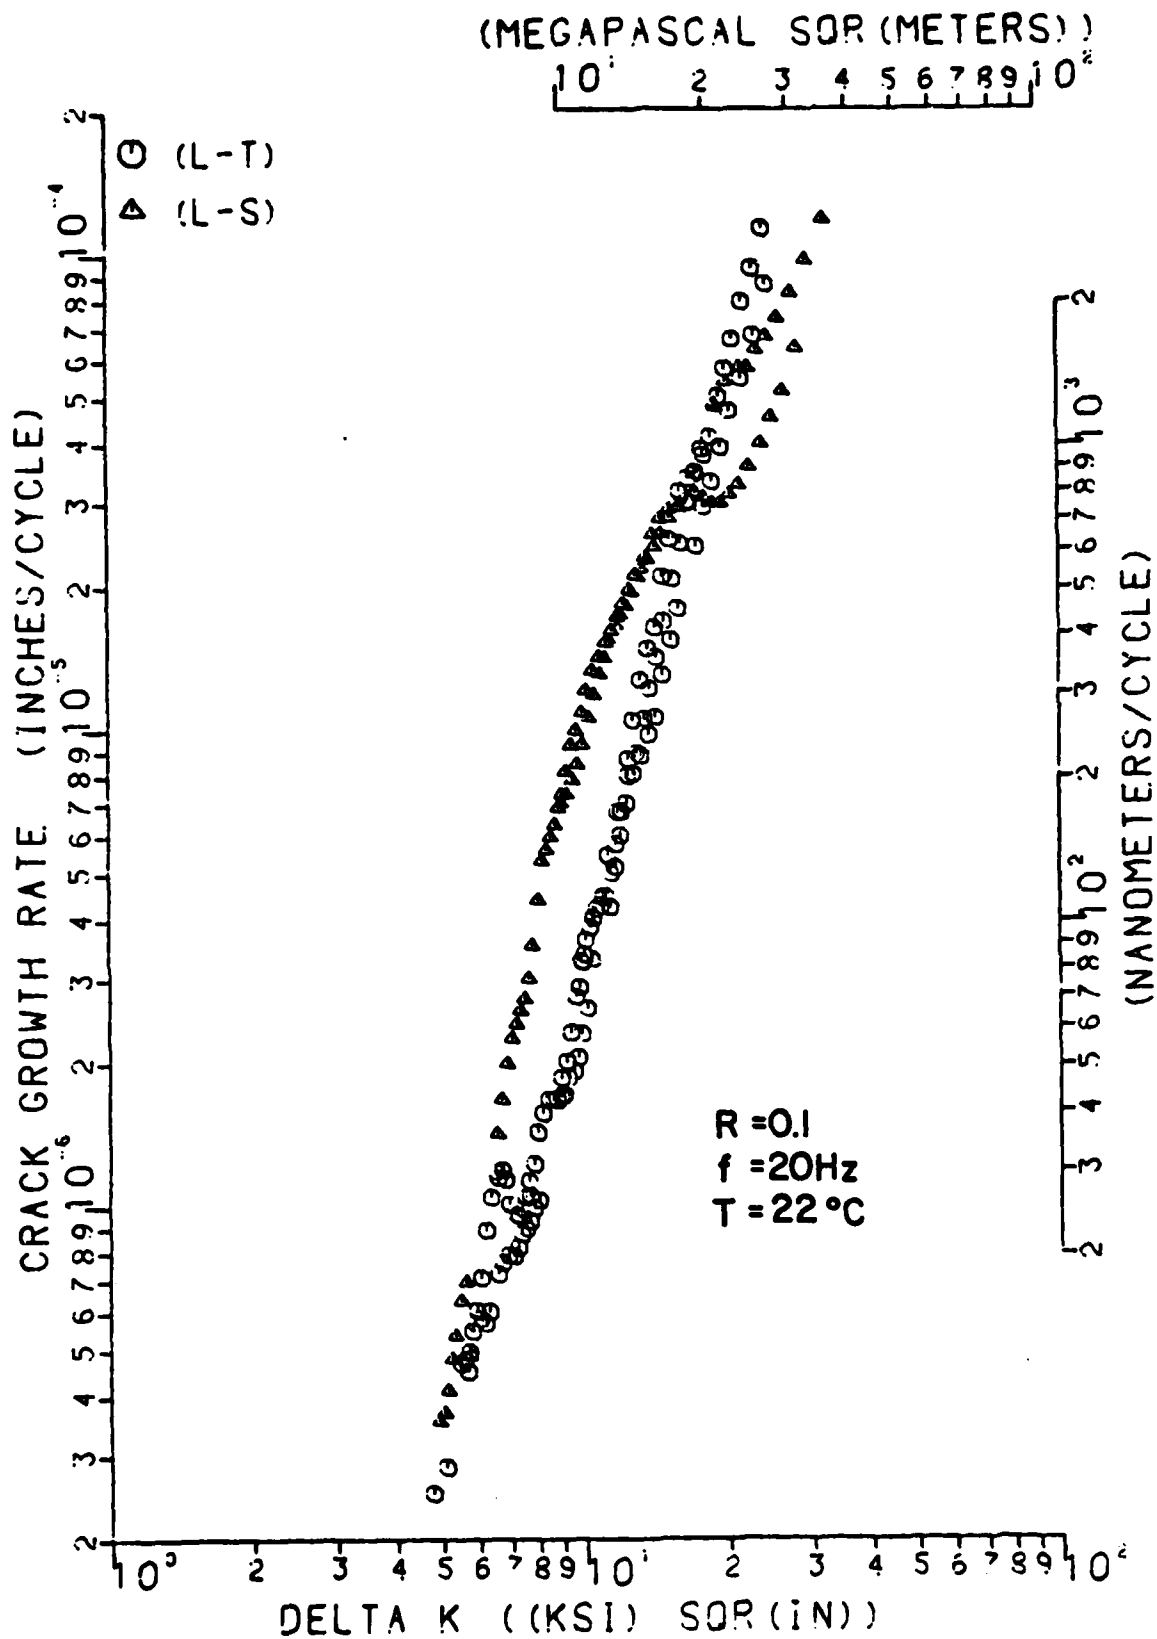
Figure 11. Constant Amplitude Loading Cyclic Crack Growth Test Results for CT Specimens Loaded in the Longitudinal Grain Direction at 72°F (22°C).

The room temperature fatigue crack growth test results are presented in Figures 11 to 13. Figure 11 presents the results for specimens loaded in the longitudinal grain direction (L-T and L-S); Figure 12 is a plot of the test data for specimens loaded in the long-transverse grain direction (T-L and T-S). There is much more scatter in the data derived from specimens where the crack propagated in the short-transverse grain direction compared to the data representing test specimens with the crack moving in the longitudinal or the long-transverse grain directions. In both figures (see Figures 11 and 12) the specimens

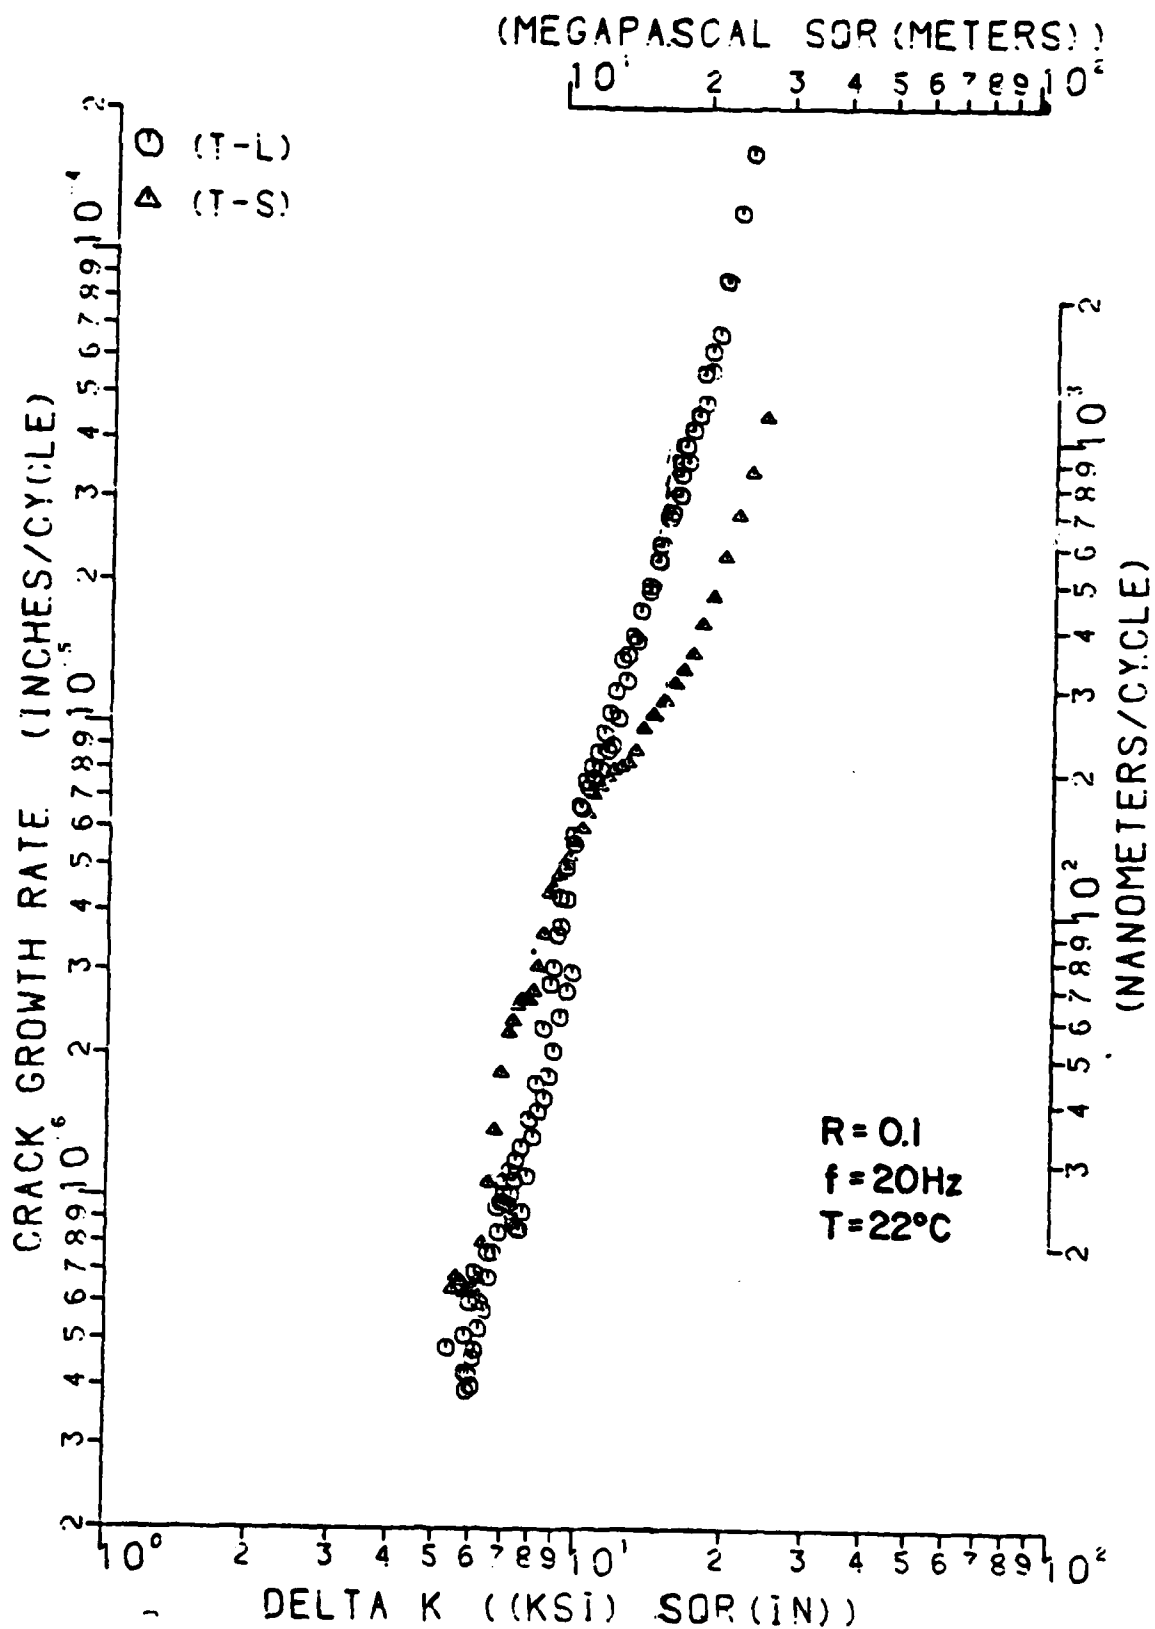
Figure 12. Constant Amplitude Loading Cyclic Crack Growth Test Results for CT Specimens Loaded in the Long-Transverse Grain Direction at 72°F (22°C).

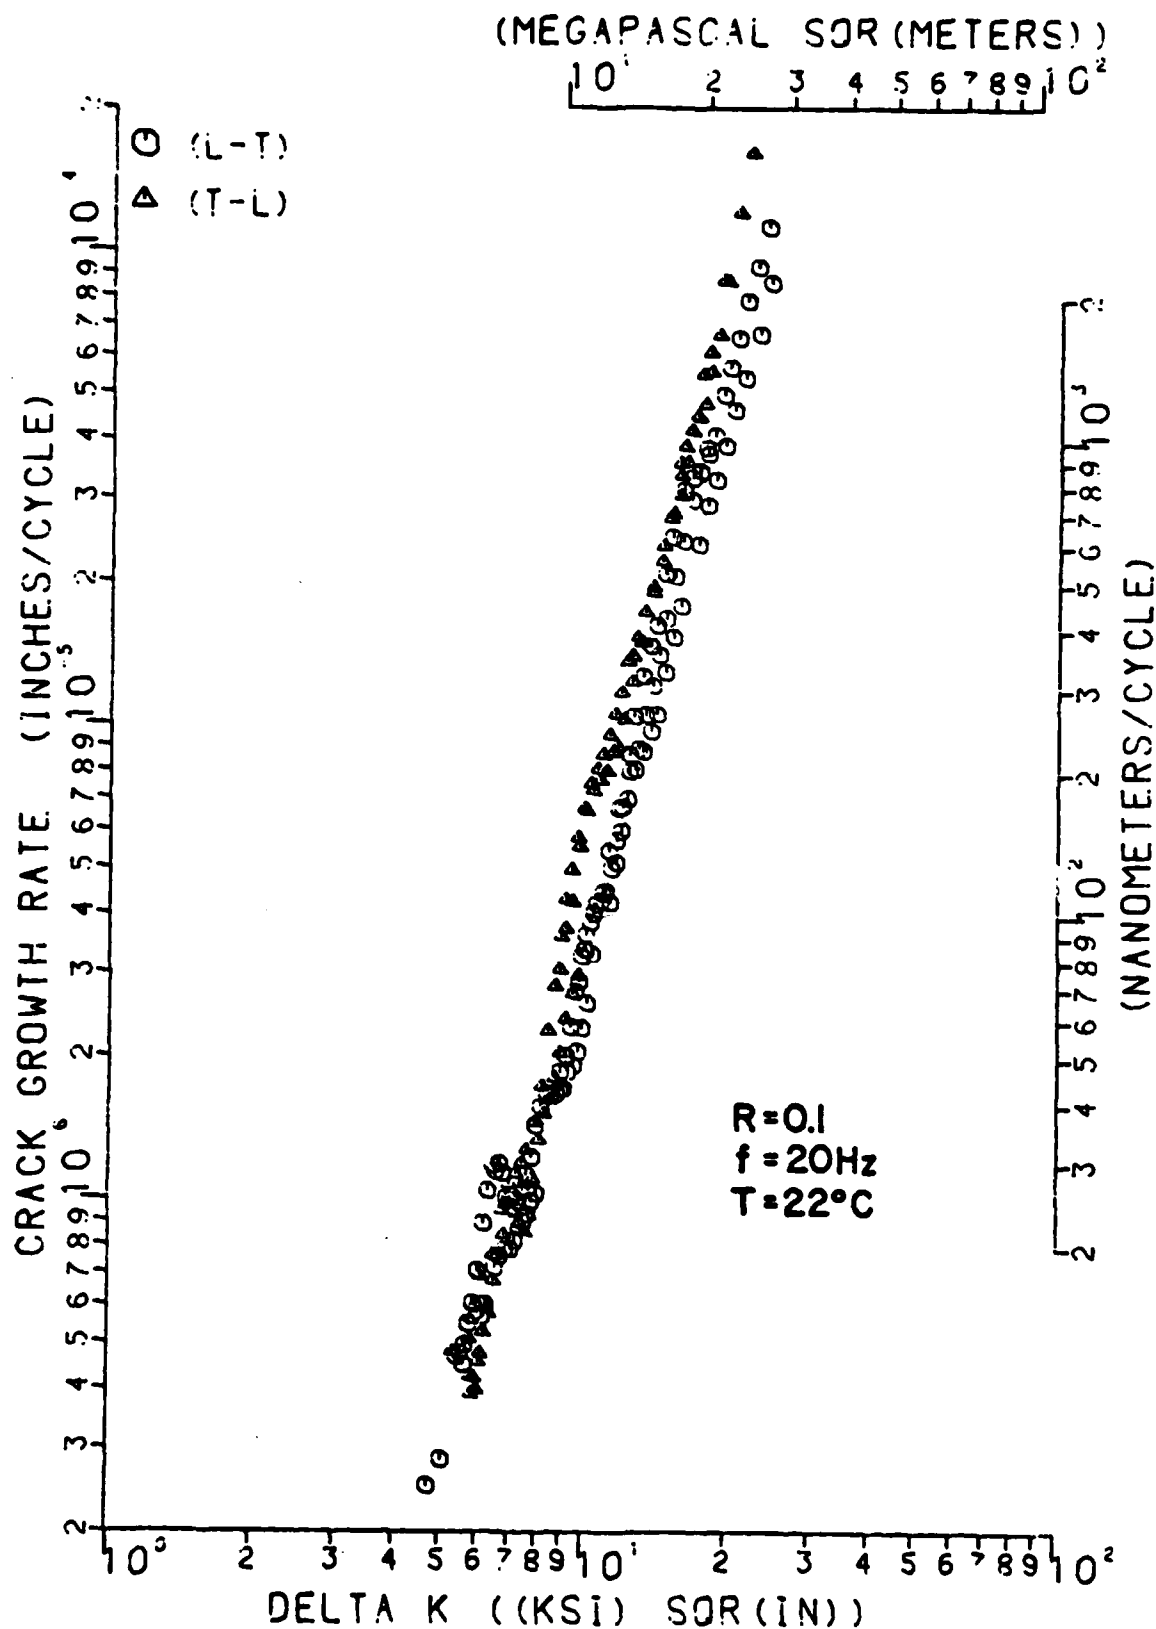
Figure 13. Constant Amplitude Loading Cyclic Crack Growth Test Results for L-T and T-L Oriented CT Specimens at 72°F (22°C).

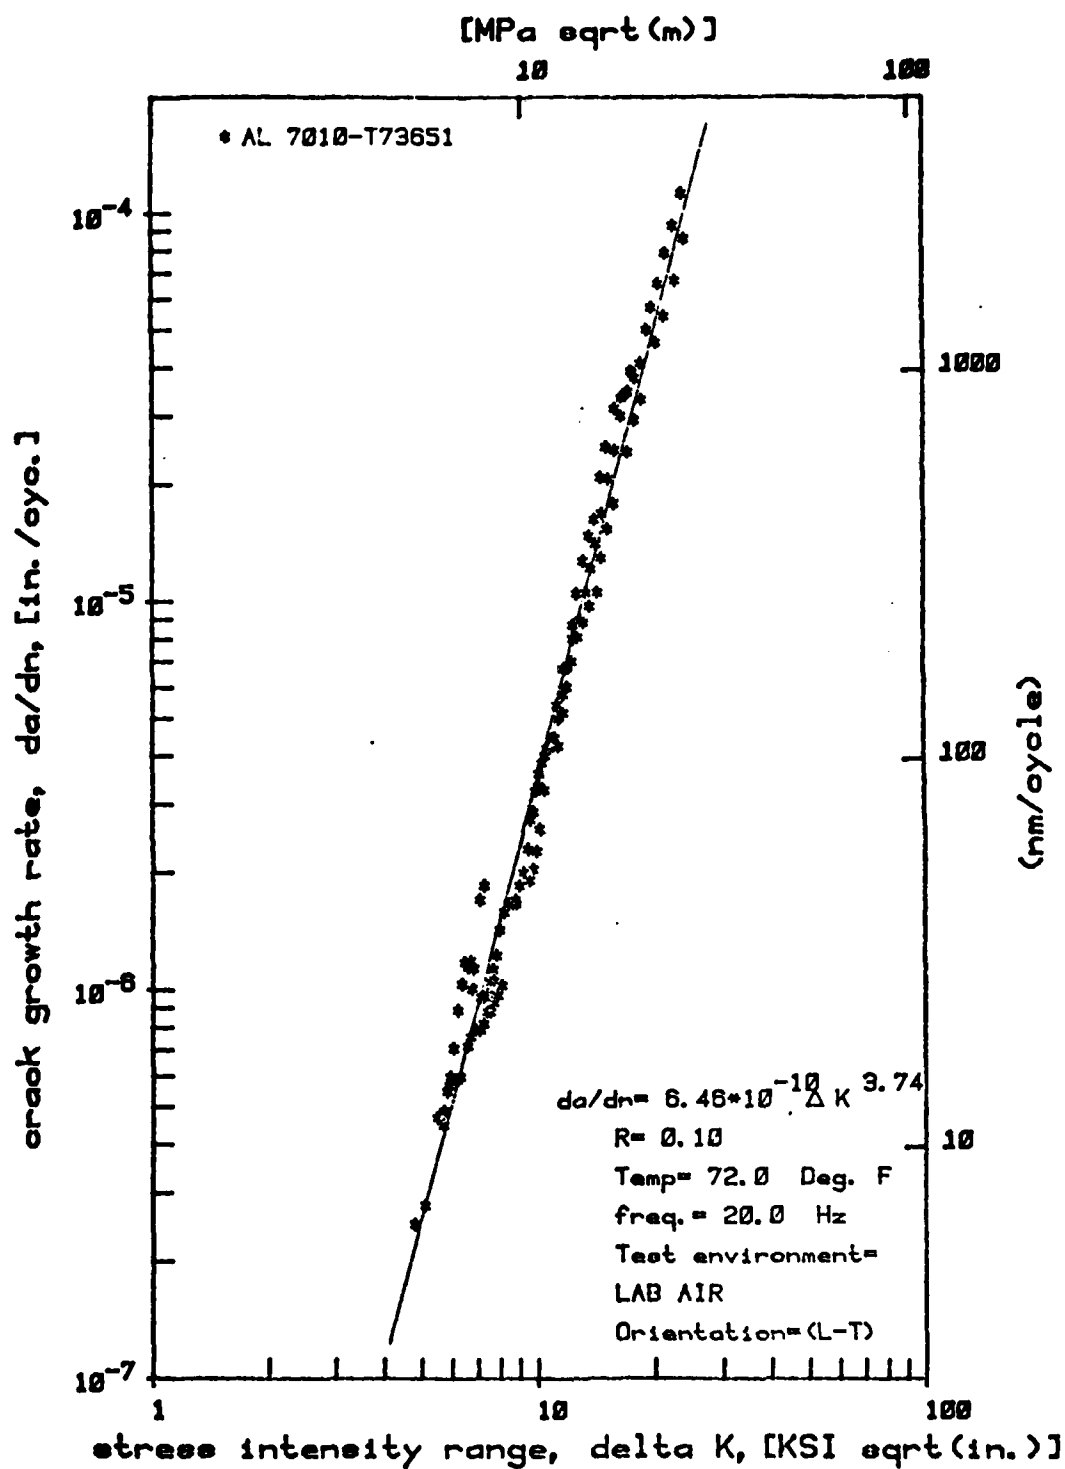
Figure 17. Room Temperature, Loading Ratio = 0.10 FCGR Test Data for Al 7010-T73651.

The constant amplitude loading fatigue crack growth test results for loading ratios equal to 0.1, 0.3, 0.5, and 0.8 are presented in Figures 17 through 20. The crack growth rate range that was considered for fitting the straight line was from 1.0×10^{-7} in./cycle (2.54 nm/cycle) to 1.0×10^{-4} in./cycle (2540 nm/cycle). For the remainder of the discussion the crack growth rates are in terms of inches per cycle, while the stress intensity range is in KSI/\sqrt{in} . In determining the best fit Paris straight line, as illustrated in Figures 17 through 20, both the Paris exponent, m , and the Paris coefficient, C , were

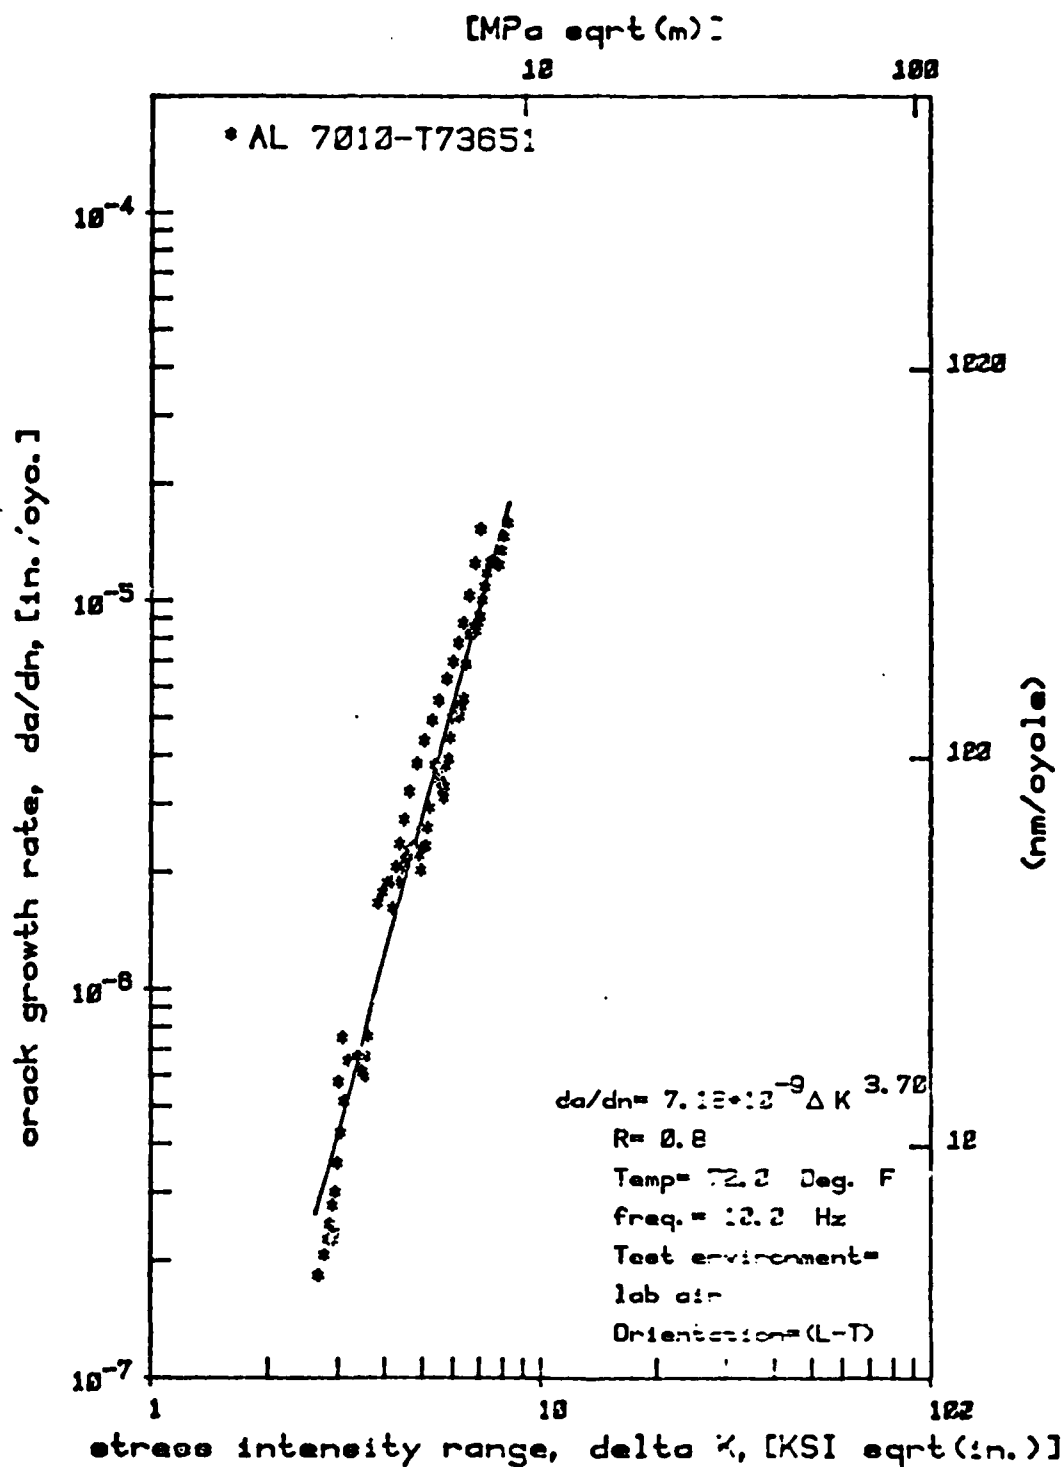
Figure 20. Room Temperature, Loading Ratio = 0.8 FCGR Test Data for Al 7010-T73651.

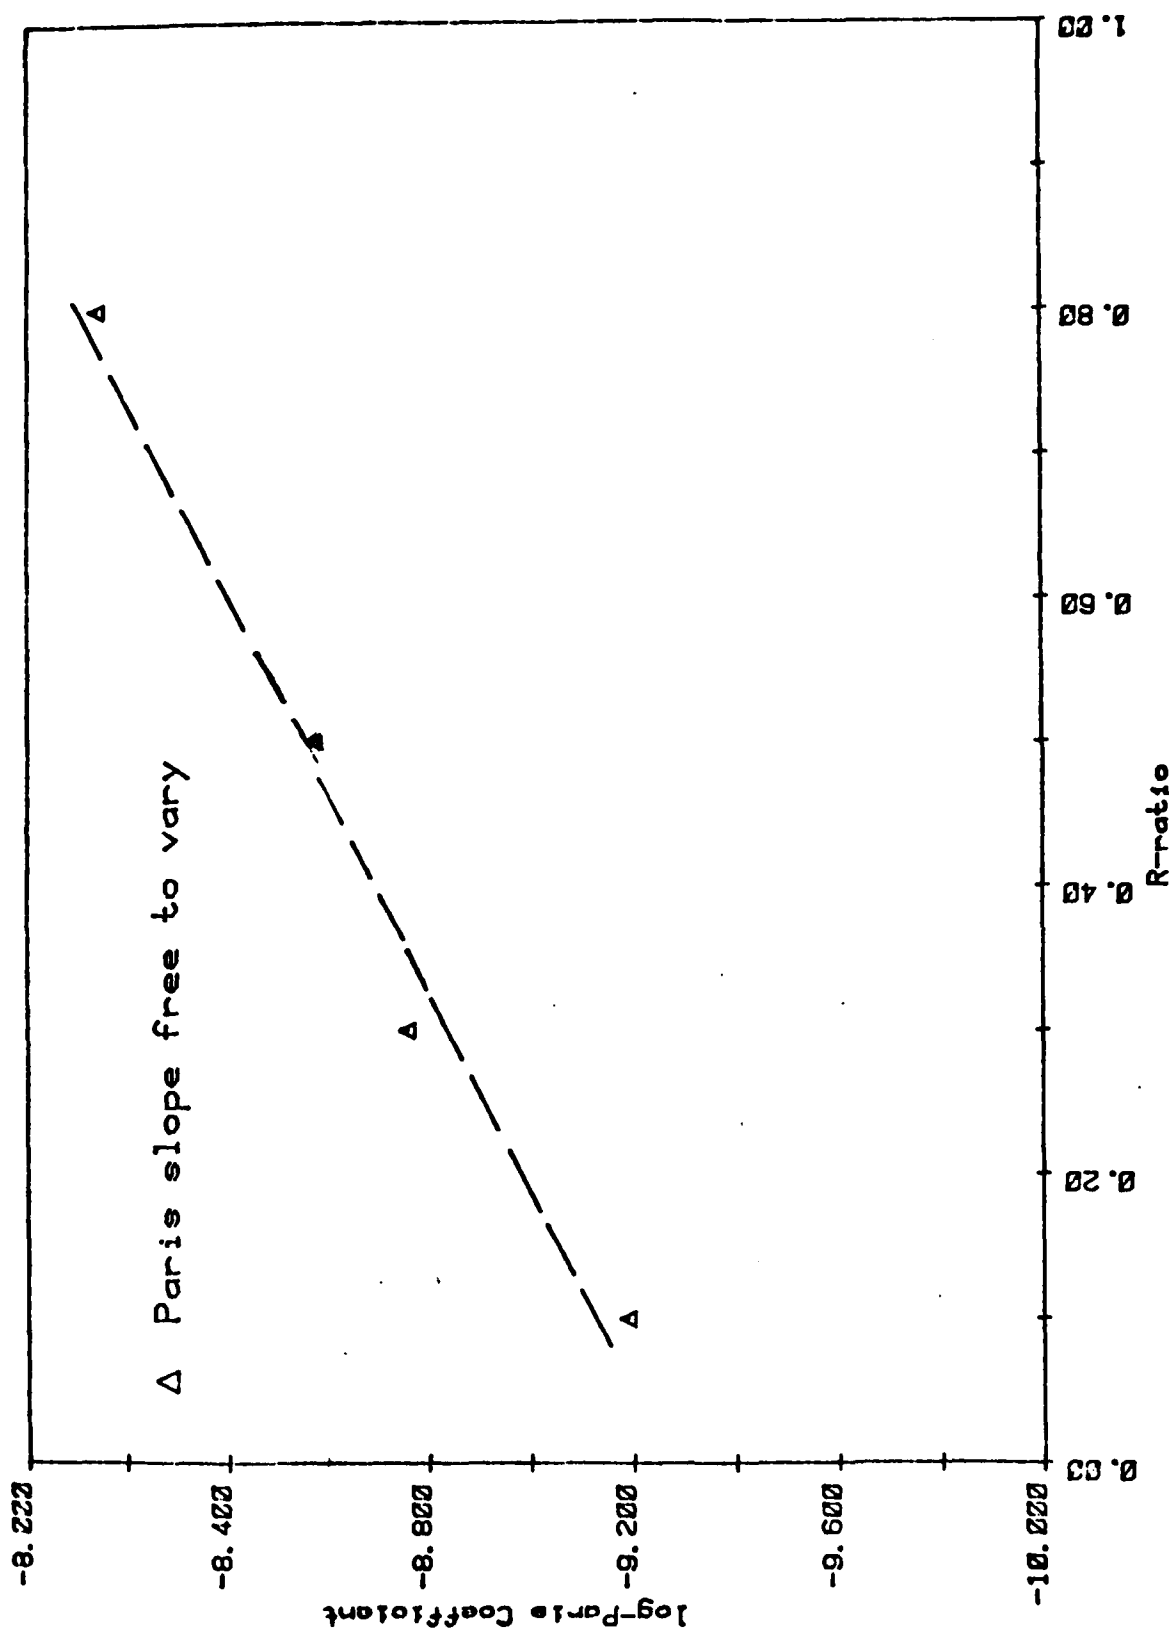
Figure 21. Loading Ratio, R, Versus Log-Paris Coefficient, Log C, for Al 7010-T73651 at 72°F (22°C).

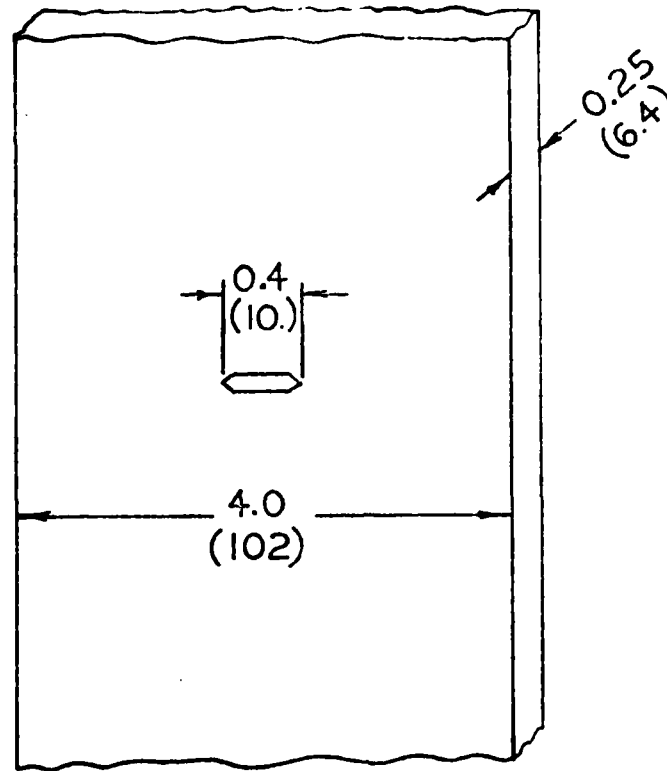
Figure 24. Center-Cracked Panel Test Geometry.

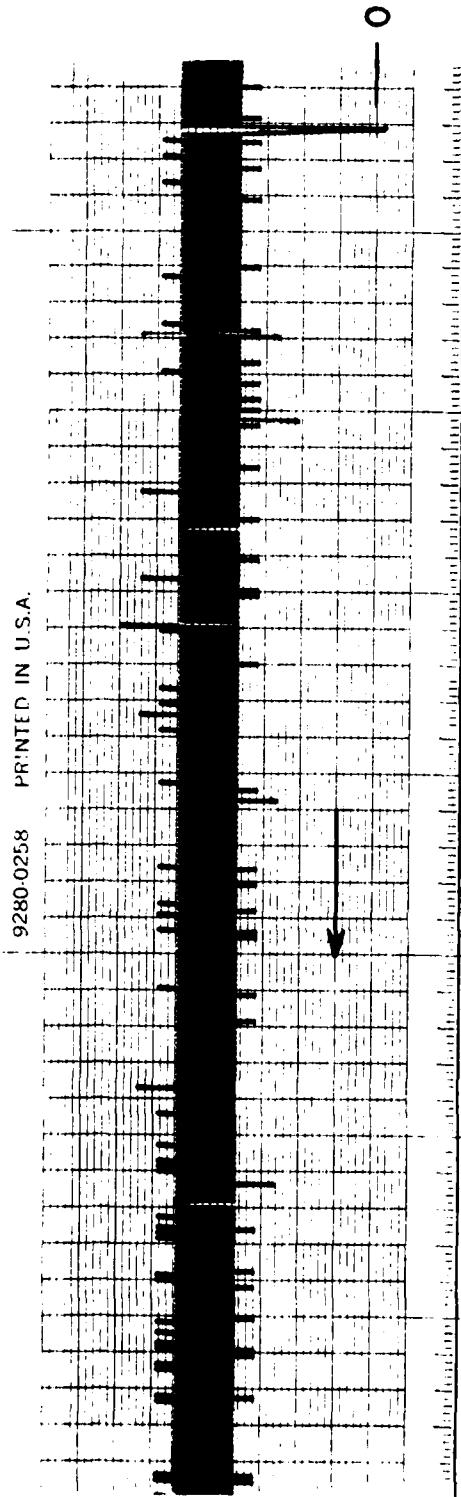
Figure 25. Portion of Load-versus-Time Record for TWIST Load History.

The load spectrum used in this investigation was the Transport Wing Standard (TWIST), developed jointly by the German Federal Republic and the Netherlands, and represents the load sequences for a transport aircraft wing skin near the main landing gear. The sequence of TWIST includes 4,000 different flights

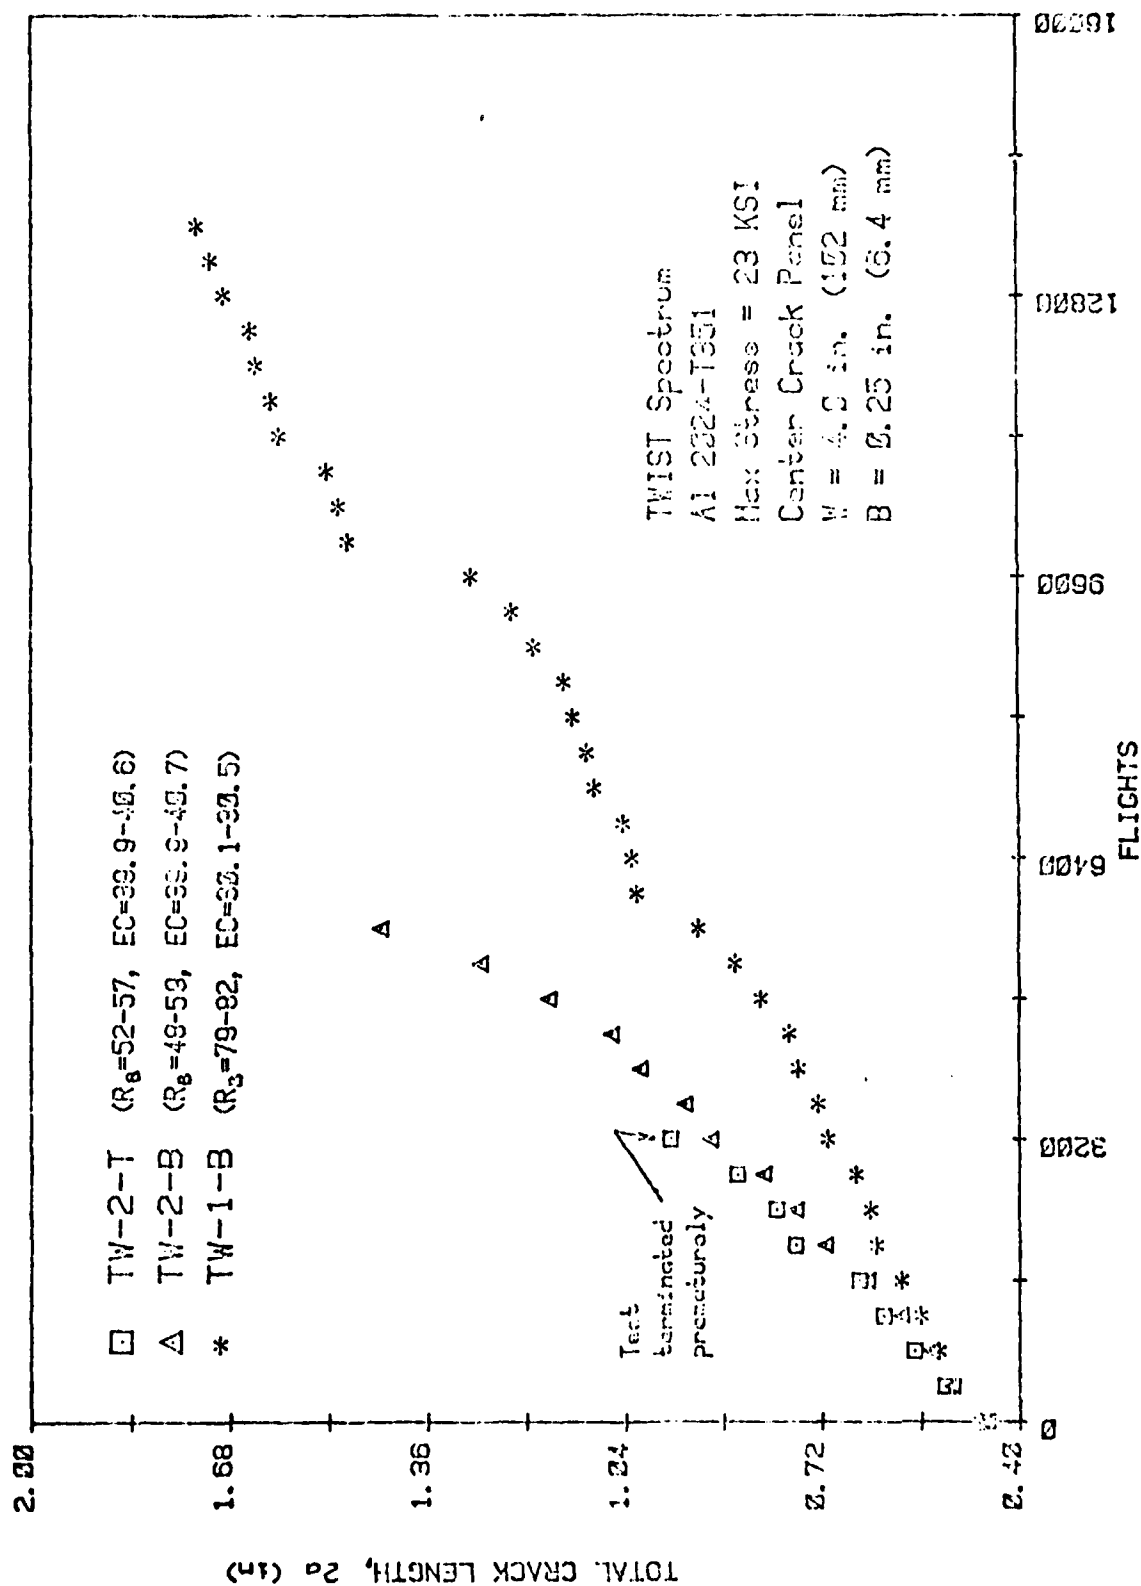
Figure 26. Spectrum Fatigue Crack Growth Data for Normal and "Soft" Aluminum 2024-T351.

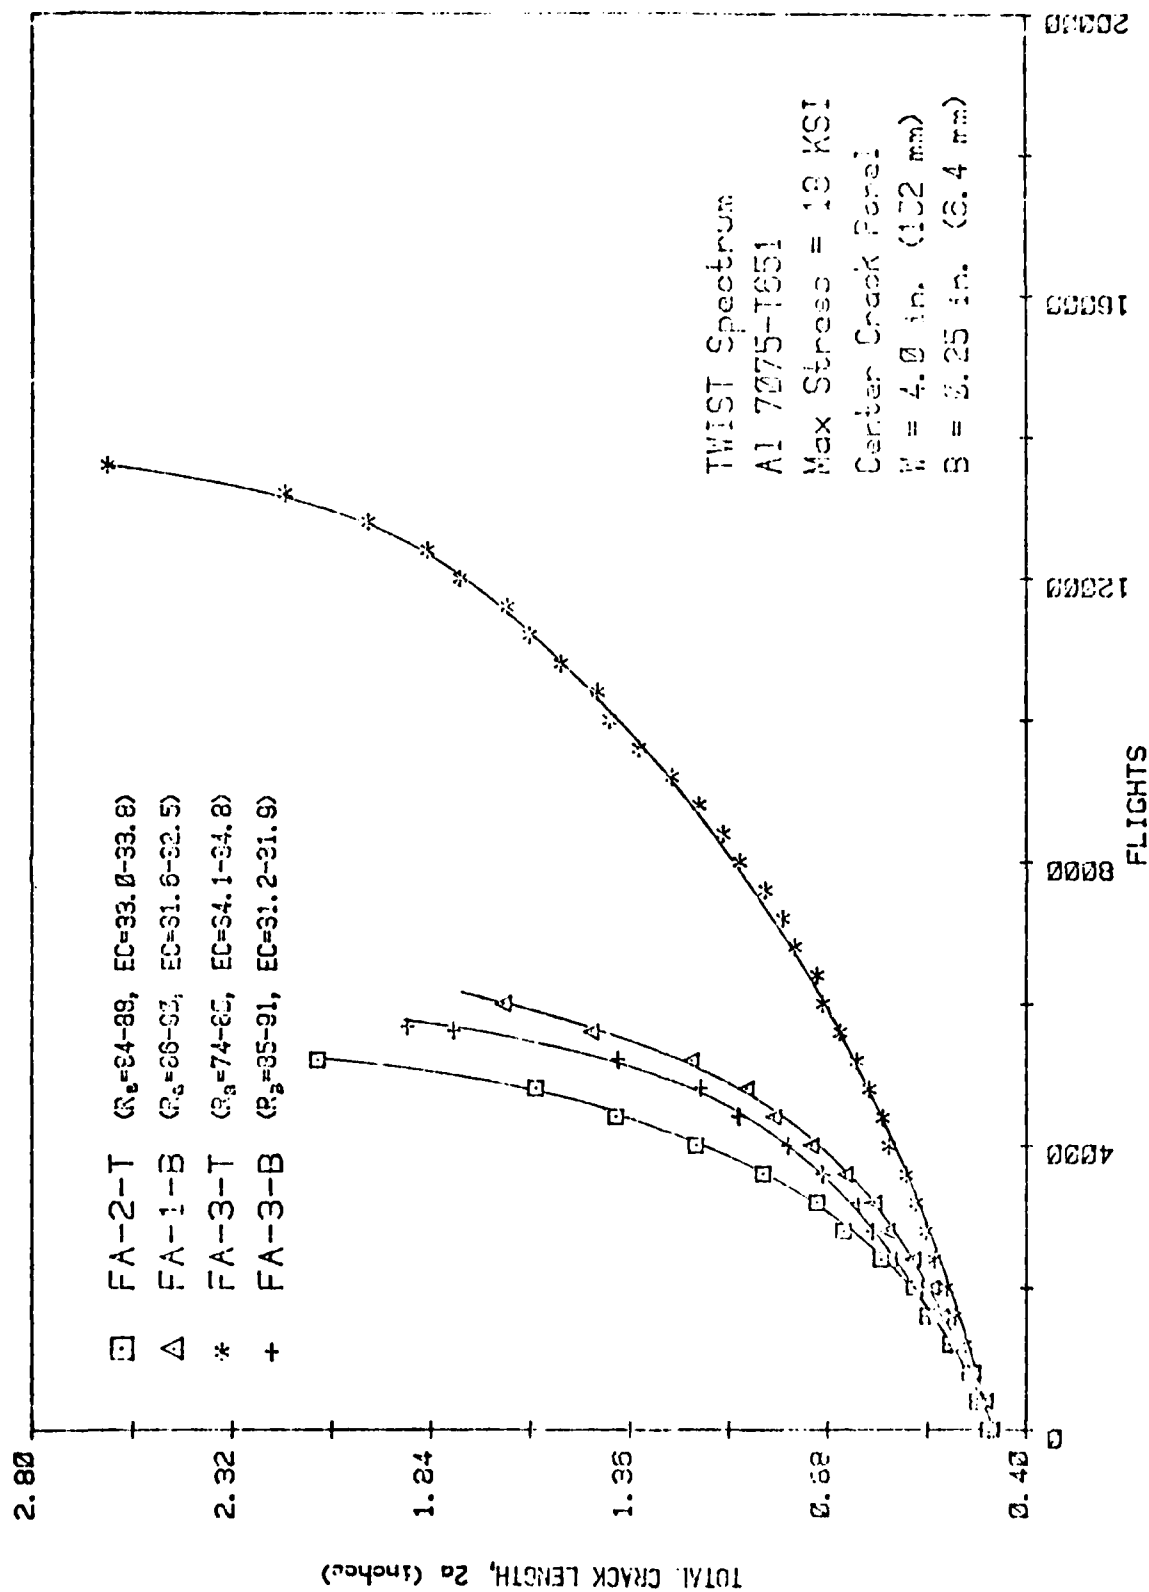
Figure 27. Spectrum Fatigue Crack Growth Data for Normal and "Soft" Aluminum 7075-T651.
